**Proven Home Inspection Service Inc.**  
5502 Woodcross Pl  
Louisville Ky 40229  
502-689-0221  
provenhomeinspection@gmail.com

## **Confidential Inspection Report**

**4321 Santa Clause Ln**  
**Bagdad**

Report: 0000011-3001 sq ft &amp; more Address: 4321 Santa Clause Ln

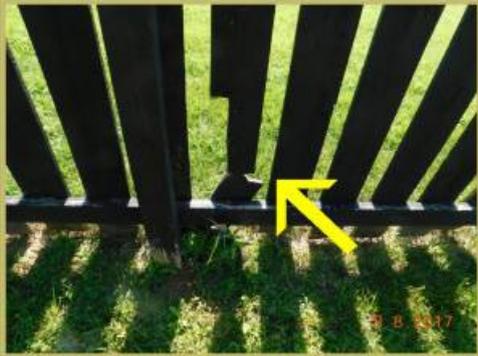
**2.11 Fence Materials Condition:**

**Attention Needed - The fencing needs to be repaired.**

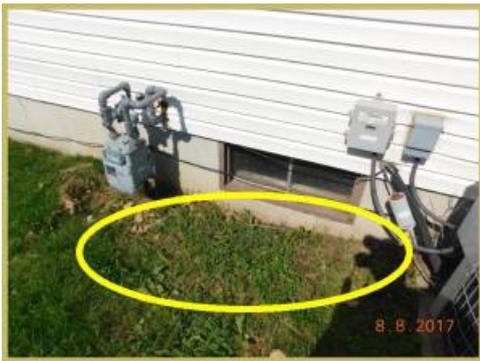
#### 3.4 Perimeter Foundation Drainage Surface:

**Action Necessary** - The drainage around the foundation needs immediate adjustment in order to divert the run-off water away from the foundation. Ground slope should be adjusted to a rate of at least 1/2 inch per foot for 6 feet away from the foundation.

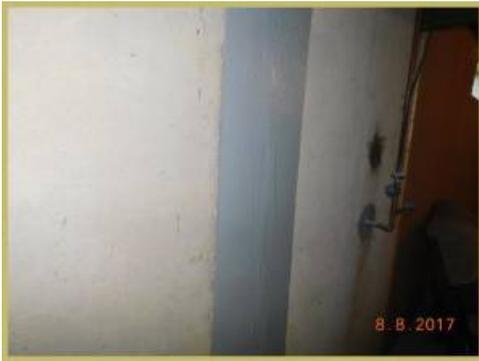
#### 3.10 Conditions Noted in Exterior Walls, Interior View:

Vertical cracks were noted in at least one exterior wall and have been repaired. [Check to see if any warranties from the repair company are extended /transferable to new ownership.](#)

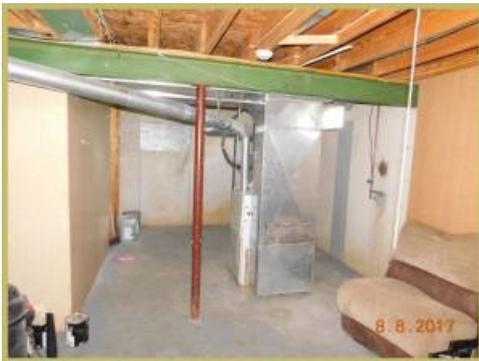
### 3.11 Columns and Posts:

There are metal columns or posts installed as supports under the main beam or girder.

There is at least one post supporting an overhead beam in the basement. It appears to be adequately installed.

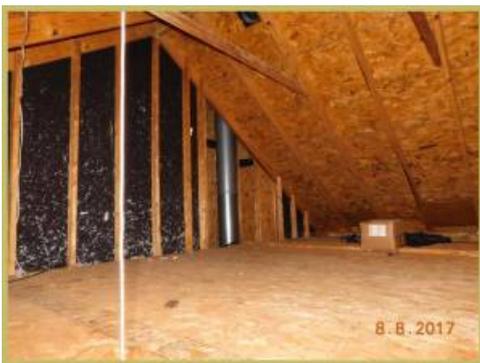
**4.13 Attic Cavity Type:**  
Room for Storage - The attic cavity has capacity for storage of light boxes or items.

**4.14 Roof Framing:**  
A rafter system is installed in the attic cavity to support the roof decking. The rafters appears to be in functional condition.

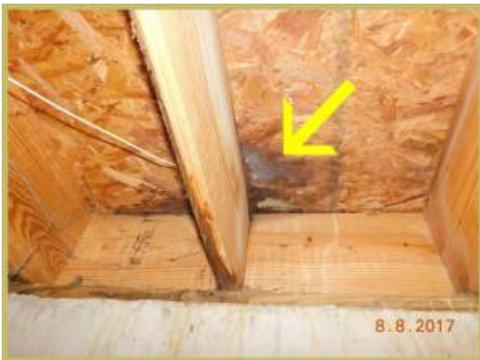
#### 5.10 Evidence of Mold Noted:

Yes. There is a mold or fungus noted on the ceiling in at least one location. This inspection does not include testing for mold type or toxicity. Further testing is recommended and needed to determine the type and the toxicity levels. A serious health hazard may exist from what appears as a simple mold. Testing for airborne mold is also excluded from this inspection.

Certain molds have been recorded as having various levels of toxicity and are known to produce respiratory and neural conditions of various intensities.

Please consider having testing completed to protect your investment and your family's health.

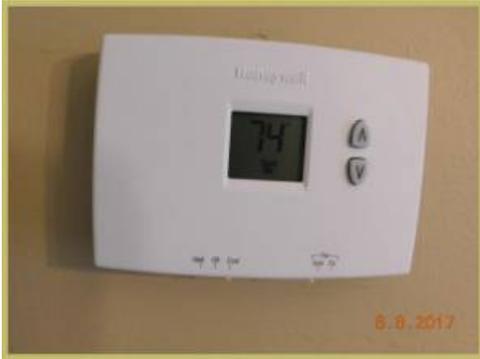
Thermostat is located in the dining room. Good - Electronic thermostat controls for central heating and air conditioning are

installed. Automatic controls were not tested or overridden.

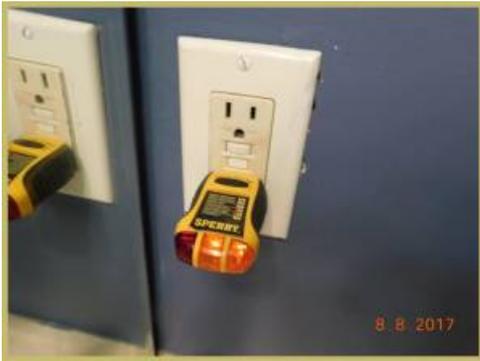
#### 7.25 Master Bathroom:

There is a functional Ground Fault Circuit Interrupt outlet installed in the area of the bathroom vanity.

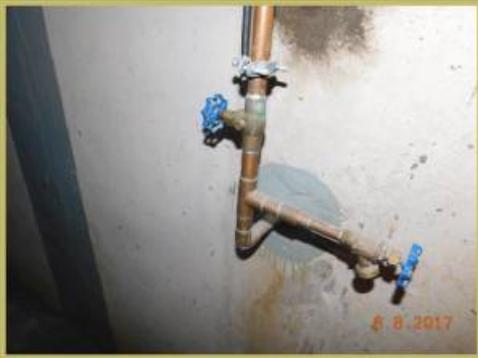
**8.2 Plumbing Service Piping Size to Structure:**

OK, 3/4" water service line from the meter to the main cutoff.

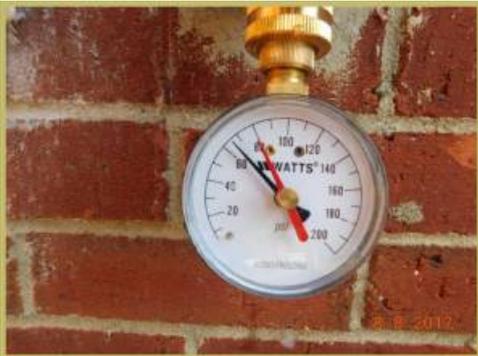
**8.7 Static Water Pressure:**

65 PSI, Water pressure was checked at an exterior hose bib. Water pressure from 40 to 80 pounds per square inch is considered within normal/acceptable range.

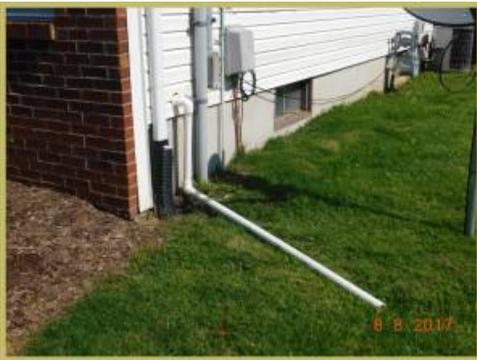
#### 8.15 Sump Pump Drain Line:

The drainage line from the sump pump is installed in such a manner that water appears to be carried far enough away from the structure to prevent reintroduction.

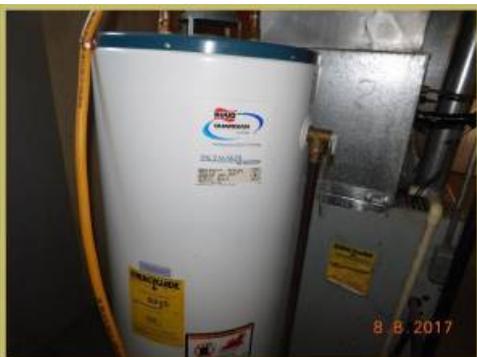
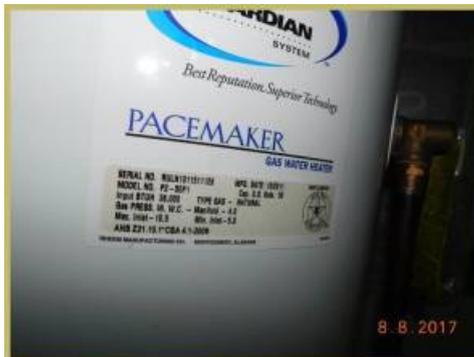
#### 8.17 Brand & Type, Age & Condition

System is Ruud brand. Unit Type: Storage Tank. MFG Date is 10/2011, The average service life for a water heater is 10 - 12 years.

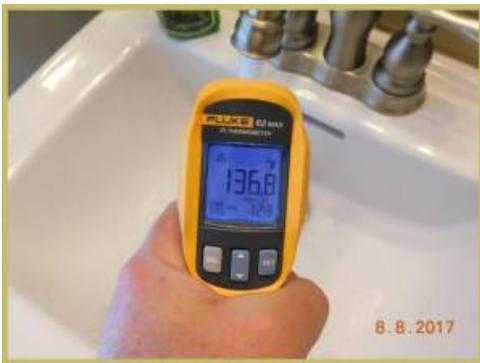
**8.25 Temperature Controls:**

Temperature controls for the most economical and relatively safe condition would be set at 120 degrees F. Temperatures in excess of 125 degrees F. are not recommended for both economic and safety reasons. **Noted temperature is 136 degrees F. scalding is possible. Recommend turning down the temperature to desired 120 degrees F.**

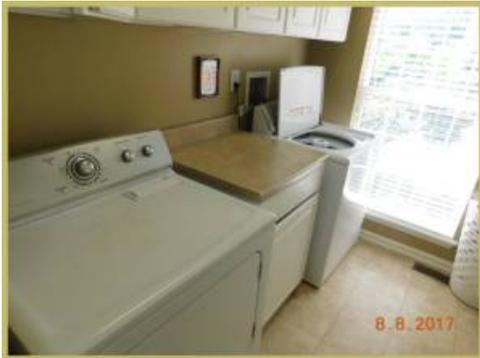
**10.1 Location:**

Located on main floor.

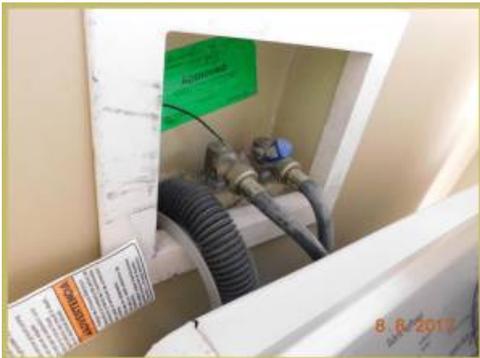
**10.2 Washer Hookup:**

There is a connection box installed in the wall with both hot and cold water and a drain pipe. The drain pipe was not flood tested.

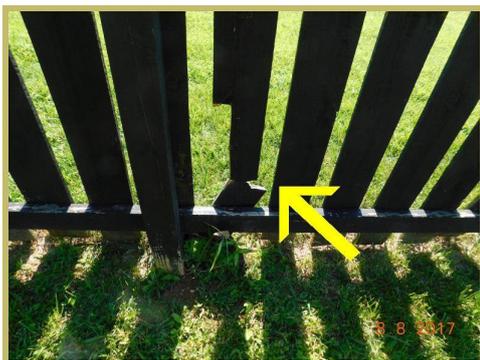
##### **2.11 Fence Materials Condition:**

- 1. Attention Needed - The fencing needs to be repaired. Repair/Replace.**

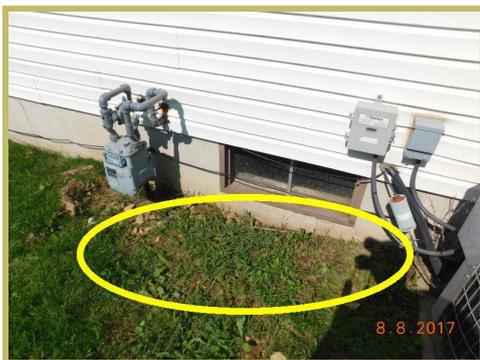
#### **3.4 Perimeter Foundation Drainage Surface:**

2. **Action Necessary** - The drainage around the foundation needs immediate adjustment in order to divert the run-off water away from the foundation. Ground slope should be adjusted to a rate of at least 1/2 inch per foot for 6 feet away from the foundation. Repair/Replace.

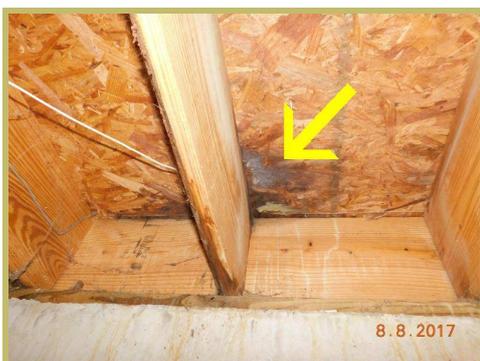
#### **5.10 Evidence of Mold Noted:**

3. Yes. There is a mold or fungus noted on the ceiling in at least one location. This inspection does not include testing for mold type or toxicity. Further testing is recommended and needed to determine the type and the toxicity levels. A serious health hazard may exist from what appears as a simple mold. Testing for airborne mold is also excluded from this inspection.

Certain molds have been recorded as having various levels of toxicity and are known to produce respiratory and neural conditions of various intensities.

Please consider having testing completed to protect your investment and your family's health.

Repair/Replace.

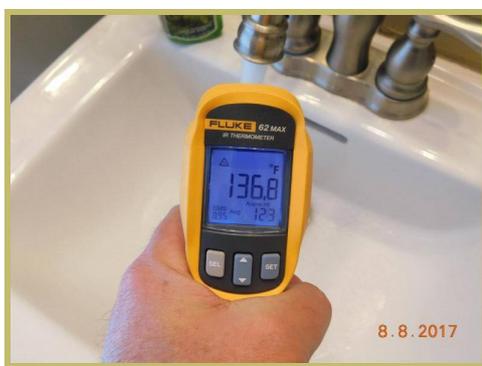
**8.25 Temperature Controls:**

5. Temperature controls for the most economical and relatively safe condition would be set at 120 degrees F. Temperatures in excess of 125 degrees F. are not recommended for both economic and safety reasons. **Noted temperature is 136 degrees F. scalding is possible. Recommend turning down the temperature to desired 120 degrees F.**
